## Effects Of Human Error On Marine Safety: Case Study

Jin-Seok Oh \*, Nayef F.S.H Al-Shammari \*\*

## II. CASE STUDY: OIL TANKER AND CARGO SHIP COLLISION

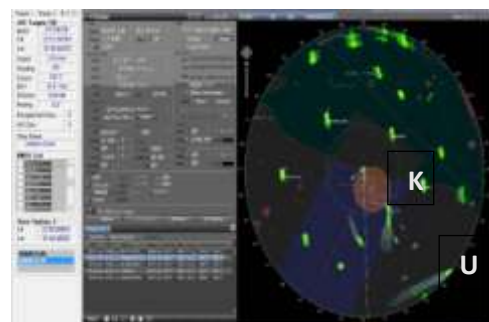
Figure 6: Radar Location of Kiafan’s “K” and Unison Star “U” (24 July 2017: 11:05) [12]

- Unison Star entered the anchorage area with relatively high speed which is against CPA polices to enter in low speed and anchorage at safe distance from other vessels.
- Kiafan’s Captain limited the risk which may affect the tanker based on general conclusions that ships working in this region are familiar and aware of the regulations and have the experience in entering such areas.
- **11:04am:** Kiafan’s bridge sailor and third officer observed that Unison Star began to retreat away from the Blue Lotus mainly due to water current effect (4.1 knots) and began to swing sharply towards the starboard direction, where it highly affected by the current in the horizontal direction. The Unison Star was on a 322o course and was running at 5.5 knots and Kaifan direction was 166.3o and the sea current was 4.1 knots as indicated in Fig. (6).

- Unison Star did not consider /estimate the high effect of water current in this area.

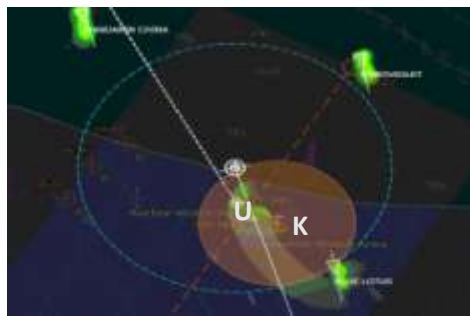
**Figure 7:** Radar Location of Kiafan’s “K” and Unison Star “U” (24 July 2017: 11:10) [12]

- Unison Star response to Kiafan radio directions. This clarify that they were able to receive the calls but they did not answer. Moreover, they did not response to the requested action by Kiafan to avoid the collision.
- Kiafan Tanker: bad evaluation of the situation led to delay in taking actions toward moving the tanker in full speed to the rear direction. This clarify the effect of experience in dealing with such situations.
- **11:09am:** the Unison Star was approximately 1.0 nautical miles from the front of Kiafan tanker. Kiafan’s captain realized that the collision was imminent, therefore he triggered the alarm and announced the possibility of collision. The collision happened at the left rear of the Unison and up to midway with the front of the Kiafan as indicated in Fig. (7).

- Unison Star: loss of ship control due to lack of experience and violation of port authority polices, where it is clearly indicated that crossing of bow at close range shall never be attempted.

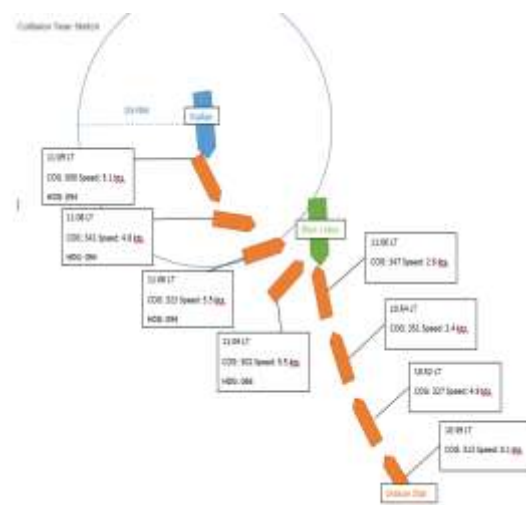
**Figure 8:** Illustration Sketch for Unison Star Collision Scenarios [12]

Fig. (8), shows a sketch diagram to the main collision time. The Figure illustrate the first possible collision between Unison Star and Blue Lotus, which not happened, and the collision events between Unison Star and Kiafan.

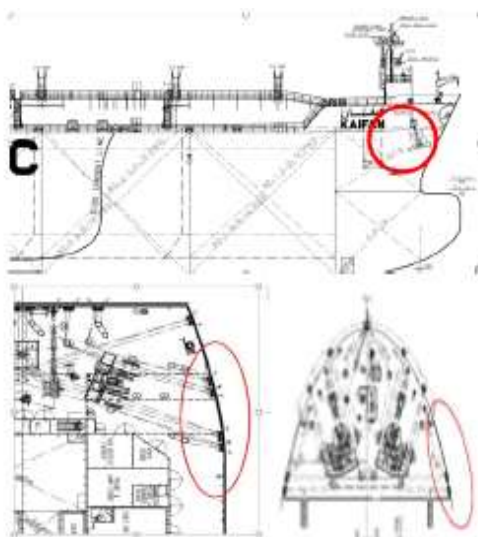
Figure 9: Locations of Kiafan's Hull Damages due to Collision [13]

The collision caused hull damage for both ships with no injuries and pollution. Beside the hull damage, Unison Star lost the main propeller and extensive maintenance needed to the main propulsion system. The detailed report of the damages caused by the collision to Kiafan oil tanker indicates the followings [Ref. Report]:

- ◆ Structural Damages include:
  - Shell plates damage and members deformed at forward starboard side
  - Shell plates damage and members deformed at bulbous bow
  - Three tie guard rails deformed and broken, emergency embarkation light post damaged, windless compressor damaged at fore castle deck and forward at starboard side
  - Shell plates damage at wing tank starboard side
  - Shell plates damage at wing tank port side
  - Shell plates damage at wing tank port side
  - Ship side shell plates damage at pot quarter Webs, side longitudinal and transverse frame deformed at steering gear room at port side
  - Aft bulkhead, web frames and scupper pipe deformed at engine room internals of port side shell plate
- ◆ 12 shackles of port anchor chain lost to sea
- ◆ The location of collision damages to Kiafan at forward port and starboard sides are illustrated in Fig. (9).
