## **GEOLOGICAL NARRATIVE OF HISTORICAL GALICIAN CEMETERIES IN TERMS OF RESTORATION**

***Abstract.** The historic cemetery is an integral part of the architectural landscape of each city, the confirmation of ideology, the spiritual and economic life of its time. Cemeteries dating back to the second half of the 18th century have been preserved in many cities of Galicia. Now we call them historical cemeteries. Most of them are no longer in use and are filled not only with historical but also artistic monuments made mainly of stone. Such cemeteries require constant care and uninterrupted supervision. Preserving the physical substance of these cemeteries is a great challenge and a difficult task. To do this, it is necessary to conduct mineralogical and petrographic studies of the stone material of the historic cemeteries of Galicia. The state of preservation of natural stone, which is most common in the historical cemeteries of Galicia, was analyzed, the types of this stone damage were investigated. Also, preventive measures to preserve the stone material of the historic cemeteries of Galicia are proposed.*

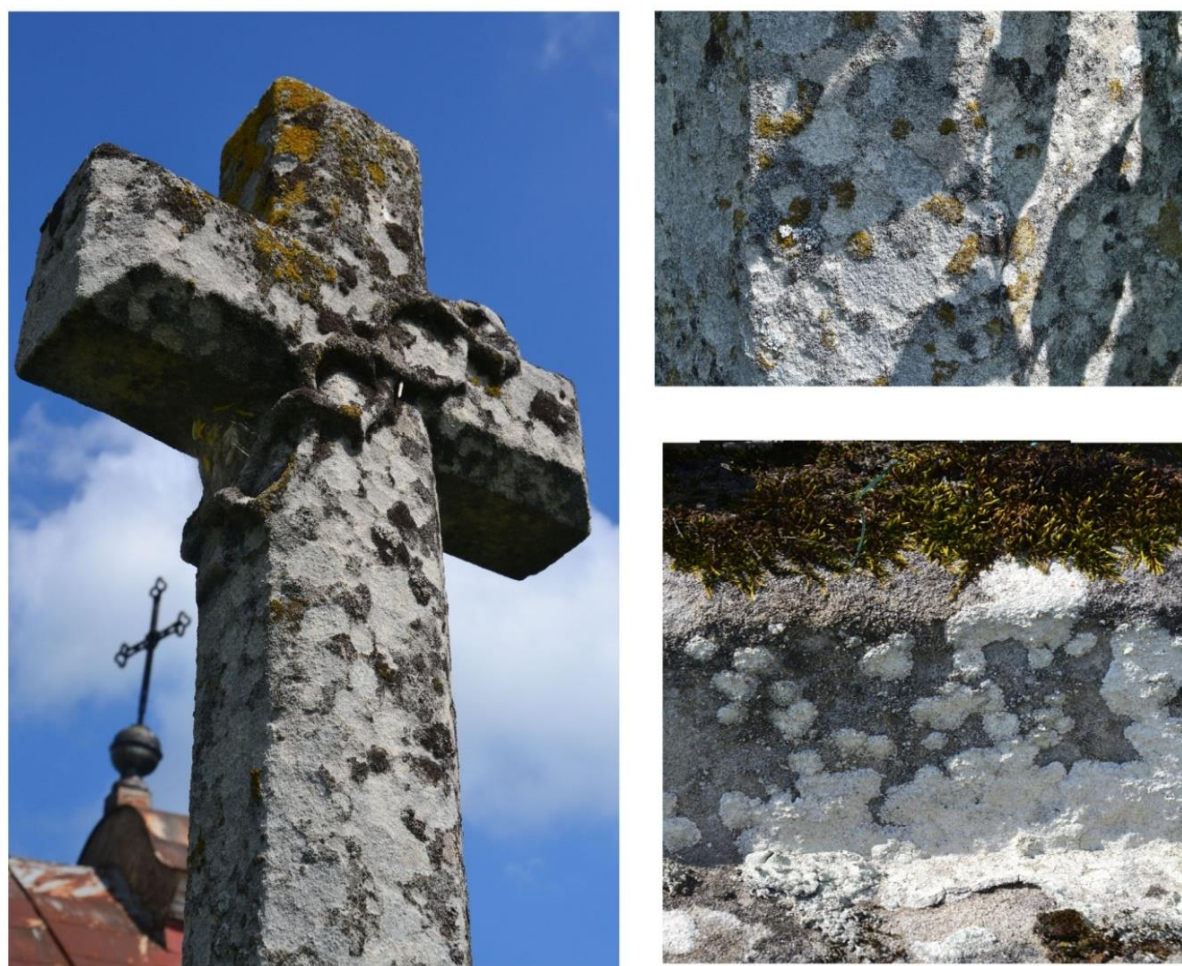
**Fig. 1. Biogrowths and the destruction of stone caused by them on the cross from the cemetery in Pidkamen**

Regarding the condition of the stone on the cemetery plastic. In a favorable situation, this means absence of vandalism, of ideological destruction of burials and natural disasters, natural stone is a very durable material. The most durable material is considered to be quartzite, granite, syenite, gabbro – their sustainability is from 250 to 650 years, but their share is insignificant on historic cemeteries in Galicia. Sandstones and limestones belong to the category of relatively durable materials, the service life of which expires in 150 years. It should be noted that the nature of the stone is such that from the moment the stone leaves the quarry, it begins to age. Limestone changes color, is covered with patina, is easily subjected to biological destruction - that is, it easily grows moss, lichen, fungi, etc. (Fig. 1). Because of this, the color of the stone becomes variegated, uneven, and the surface layer is easily destroyed.

Sandstone, like limestone, is compliant to biological destruction - that is, it easily grows moss, lichen, fungi, and so on. Small cavities are used by insects, which deepen them and use for housing. Under the influence of atmospheric and biological factors it changes color, covered with patina. Due to the structural features of the rock can be stratified on the planes of stratification (characteristic of Terebovlya sandstone). In areas of weak cementation, it may crack, especially when it is exacerbated by atmospheric or biological factors. Granite, labradorite are the most durable of the stones that are widely used in cemetery plastics. They do not change color, are not easily and quickly subjected to biological destruction. The polished texture of processing gives them special stability.

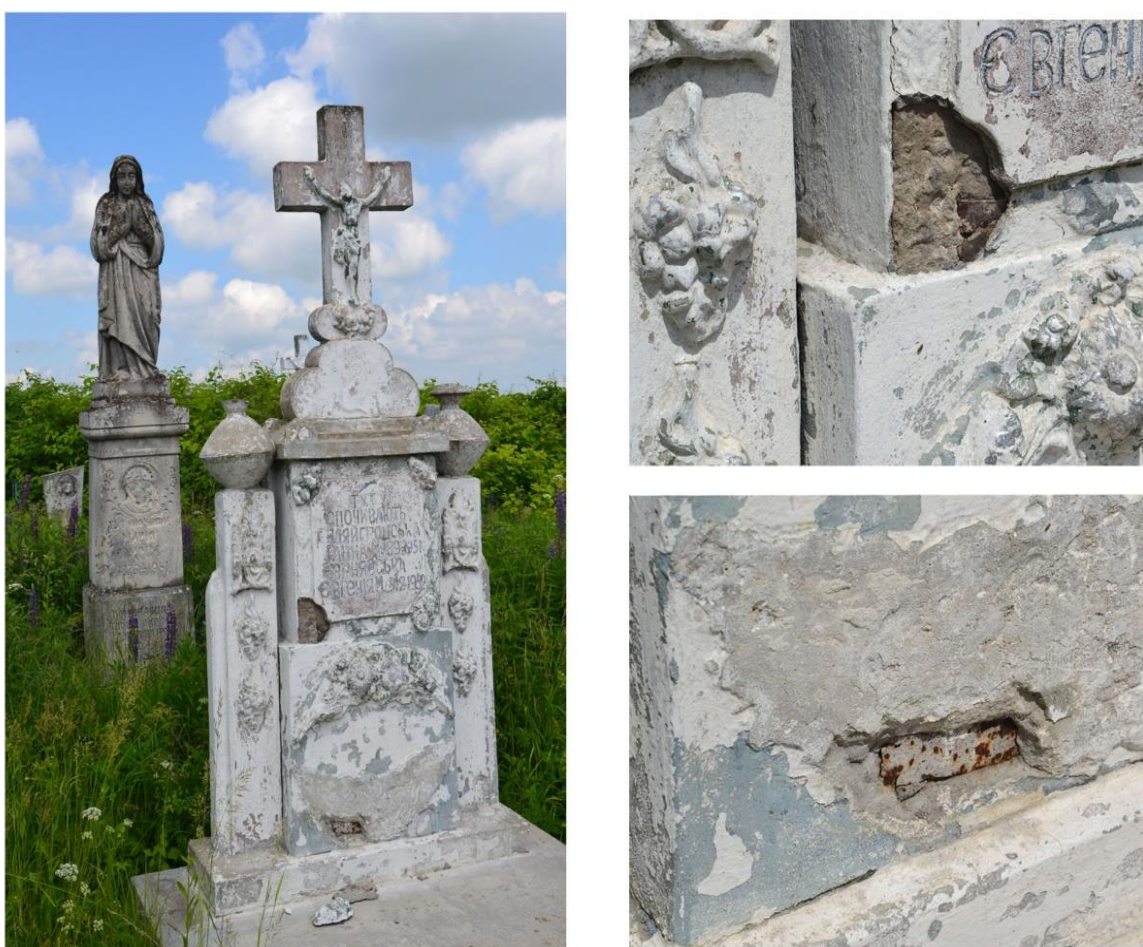
**Fig. 2. Destruction of a monument made of reinforced concrete**

Beginning from the middle of the 19th century, monuments made of so-called artificial stone began to appear in cemeteries. In this case concrete, and more often reinforced concrete. Very often, military burials from the First World War were built of reinforced concrete. Most often it was just crosses. We can see such military fields on the territory of many historical cemeteries of Galicia. Many sculptors in the early twentieth century were willing to work with this new material. It is very malleable and allows you to perform complex structures that cannot be made of natural stone. Actually largely due to metal structures. And it is the metal structures, and in fact the oxidation and rusting of the metal that cause the destruction of many of these monuments (Fig. 2).

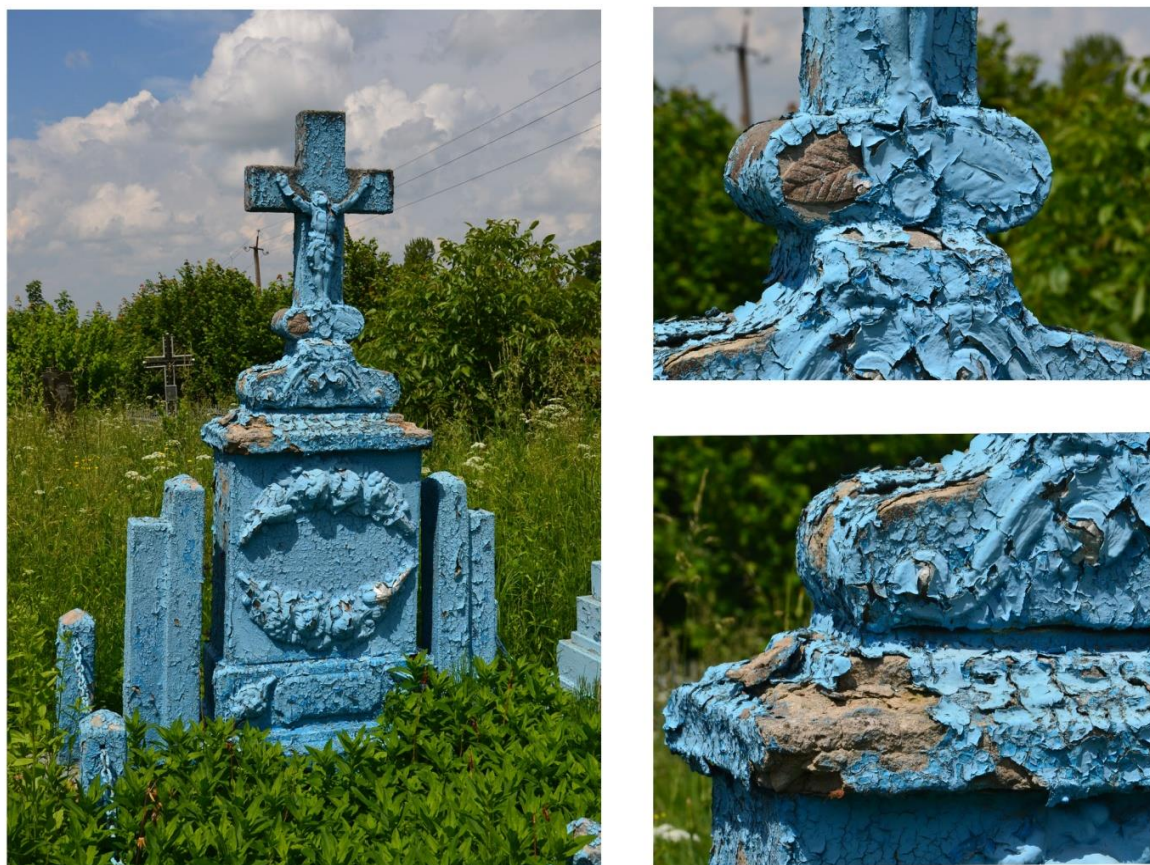
**Fig. 3. Destruction of a stone covered with oil paint**

problem is painting stone monuments. Most often in the late twentieth and early twenty-first century it was oil paint. The results of such actions are simply catastrophic. Under a layer of inappropriate paint, the stone is destroyed and crumbles. Over time, the paint begins to crack and crumble along with pieces of stone (Fig. 3). This applies not only to oil paint. Drawing a stone with any inappropriate paint and in the wrong way will lead to a similar result.
