**ENVIRONMENTAL PROBLEMS AND THEIR SOLUTION DURING  
CONSTRUCTION AND OPERATION OF ST. PETERSBURG BARRIER  
FLOOD PROTECTION**

*Victor I. Popov<sup>1\*</sup>, Lev M. Monosov<sup>2</sup>, Igor V. Polischuk<sup>3</sup>*

RESEARCH ARTICLE

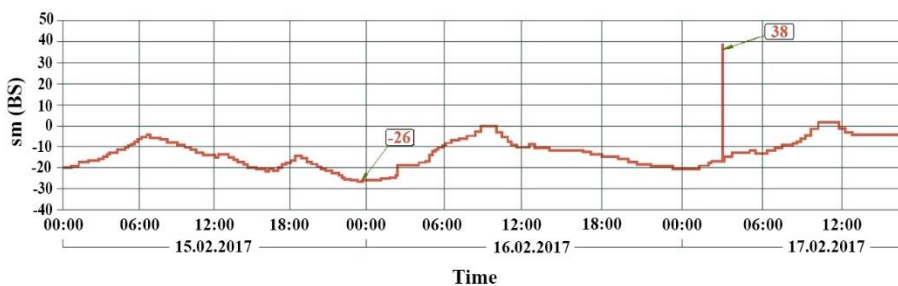
Figure 3 Water Level below the ordinary on the date of 15.02.2017.

At this time, a number of well-known experts claimed that the construction of protective structures led to a violation of the hydrodynamic, hydrochemical and hydrobiological relationship of the Finland Gulf and the Neva Bay. At the same time, they attributed the deterioration of the sanitary condition of the Neva Bay to the construction of protective structures, and not to a sharp increase in concentrated discharges into the Northern channels of the Neva river Delta from centralized treatment facilities. However the Neva Bay is merged with the Finland Gulf by two Straits: the Northern and Southern gates, which have extensive shoals that prevent the penetration of sea wind waves and wind currents into the Neva Bay, the removal of ice from the Bay To the Gulf, and hinder water exchange between fresh and brackish waters of the Bay. Therefore, the Neva Bay is essentially a closed basin, which has always formed a local hydrological regime, little affected by the Gulf of Finland. Some experts believed that floods contribute to the purification of the Neva Bay and the Delta of the Neva. As shown numerous field tests a result of intensive cyclonic activity during floods in the Eastern part of the Finland Gulf there has always been a mixing of waters and a retreat to the West of the wedge of brackish water (from 30 to 90 km) from the target of protective structures and therefore their statements should be considered incorrect. The design solutions implemented correctly during the construction process did not change the system of currents, wave and temperature regimes, or the natural regime of water levels in the Neva Bay and the Delta of the river. Neva. As in everyday life, the project provided levels well below the ordinary (Figure 3).

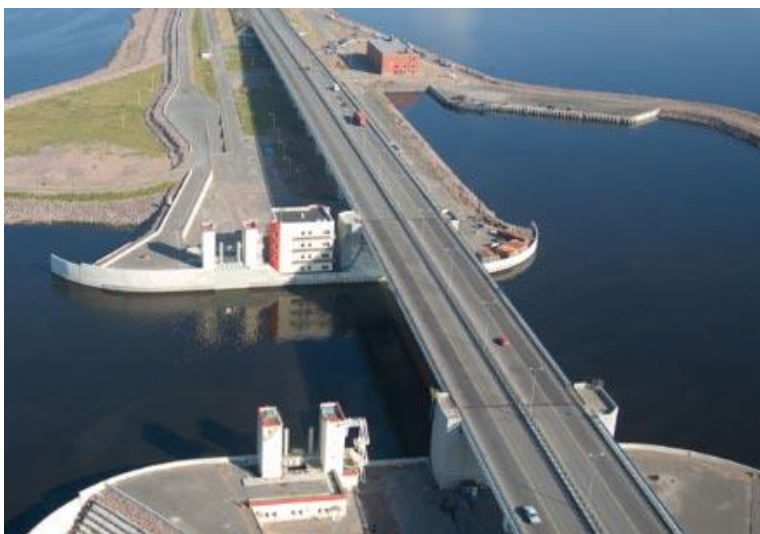
*Figure 4 Drawbridge with ship-passing structure C-2*

In 2004, the Russian Government entered into a loan agreement with the EBRD to finance the completion of the KZS. Considering that the project has not been conserved for 14 years, the unfinished objects have actually become a source of environmental pollution of the Neva Bay. Leading Russian specialists, as well as foreign experts from the UK (Halkrou) and the Netherlands (Roal Haskoning) were involved in the development of the project documentation for the completion of the KZS. The completion project contained a section on the environmental justification of the facility (environmental Protection). The construction of the barrier began in 2006. 6 contracts were concluded on the basis of standard FIDIC contracts (red and yellow books). Since the beginning of the construction of the KZS, the problem of pollution was gradually decrease and contribute to this the conditions created for the completion of the construction of KZS facilities. During the operation of the Complex, as well as during the construction period, environmental issues were also much attention was paid [1]. The required quality of environmental safety was also monitored by environmental experts from the EBRD occasionally visited the facility under construction. Also constant supervision was provided for the government Agency for technological and environmental monitoring (Rostekhnadzor of Russia). In 2010, the KZS Directorate issued decisions on granting a water body for use, which defined a safety zone, including an environmental zone in the Baltic sea. The total area of this zone, for which the KZS Directorate is responsible, is 21 square km. The main threat to the adjacent water basin during the operation of the KZS is surface water runoff (diffusive runoff) from the roadway of the marine section of the ring road. On this section of 25.4 km long, the six-lane highway is capable of passing up to 27,500 vehicles per day at an estimated speed of 120 km/h. Taking into account the high and increasing traffic intensity along the highway every year, a systematic approach was developed and implemented to collect, divert and clean up the entire volume of polluted water. These large-scale measures made it possible to prevent the discharge of untreated sewage into the water area. The complexity of the organizing task for collection and treatment of effluents from the entire KZS was associated with extremely limited areas of dams and the presence of six bridges on the route at the culverts and at the C-2 ship-passing structure of the drawbridge and a deep-water road tunnel (Fig.4) [1, 2]. System of drainage pipes and trays placed above the bridge are intended for clean the diffusion runoff from the roadway of bridges over culverts. Water supplied for cleaning in special combined filter cartridges filled with

clinoptilolite (a mineral from the Kholinsky Deposit of Buryatia) and activated carbon. 118 such filter cartridges are installed on the bridge supports.
